PETROGRAPHIC EXAMINATION OF BELL CANYON TESTS (BCT)

MISCELLANEOUS PAPER SL-83-12

# PETROGRAPHIC EXAMINATION OF BELL CANYON TESTS (BCT) 1-FF FIELD GROUTS OVER A THREE-YEAR PERIOD

U. S. Army Engineer Waterways Experiment Station  
P. O. Box 631, Vicksburg, Miss. 39180

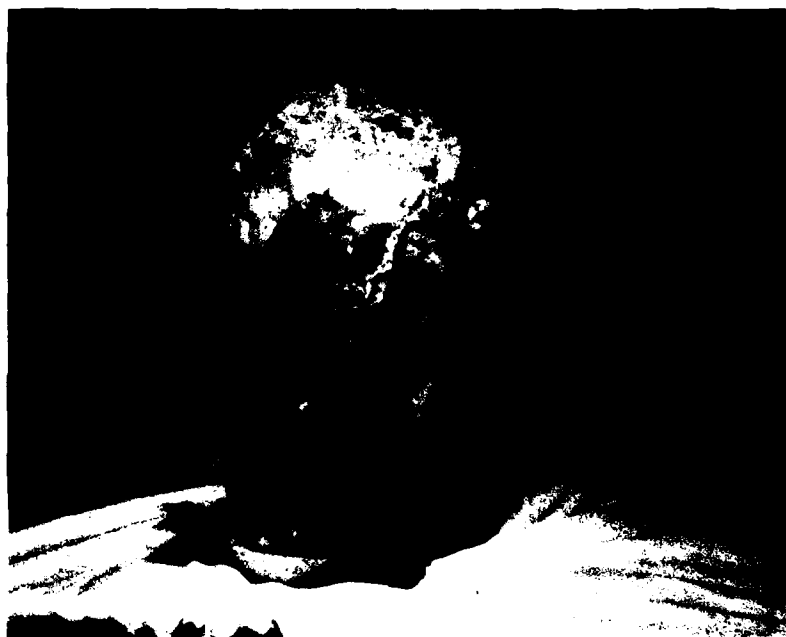
Figure 5. Sample A12 from satellite Hole 4. The sand was mixed into most of it. Note the voids in the sample due to the turbulence during placement. The sample is 1.1 ft long

- f. Examination of grout from the upper and lower parts of satellite holes showed that sand from the bottom of the hole was carried up into the grout during placement and that brine already present in these holes caused areas of high water content incompetent grout in these samples.
